EXCAVATED DIRT STOCKPILES

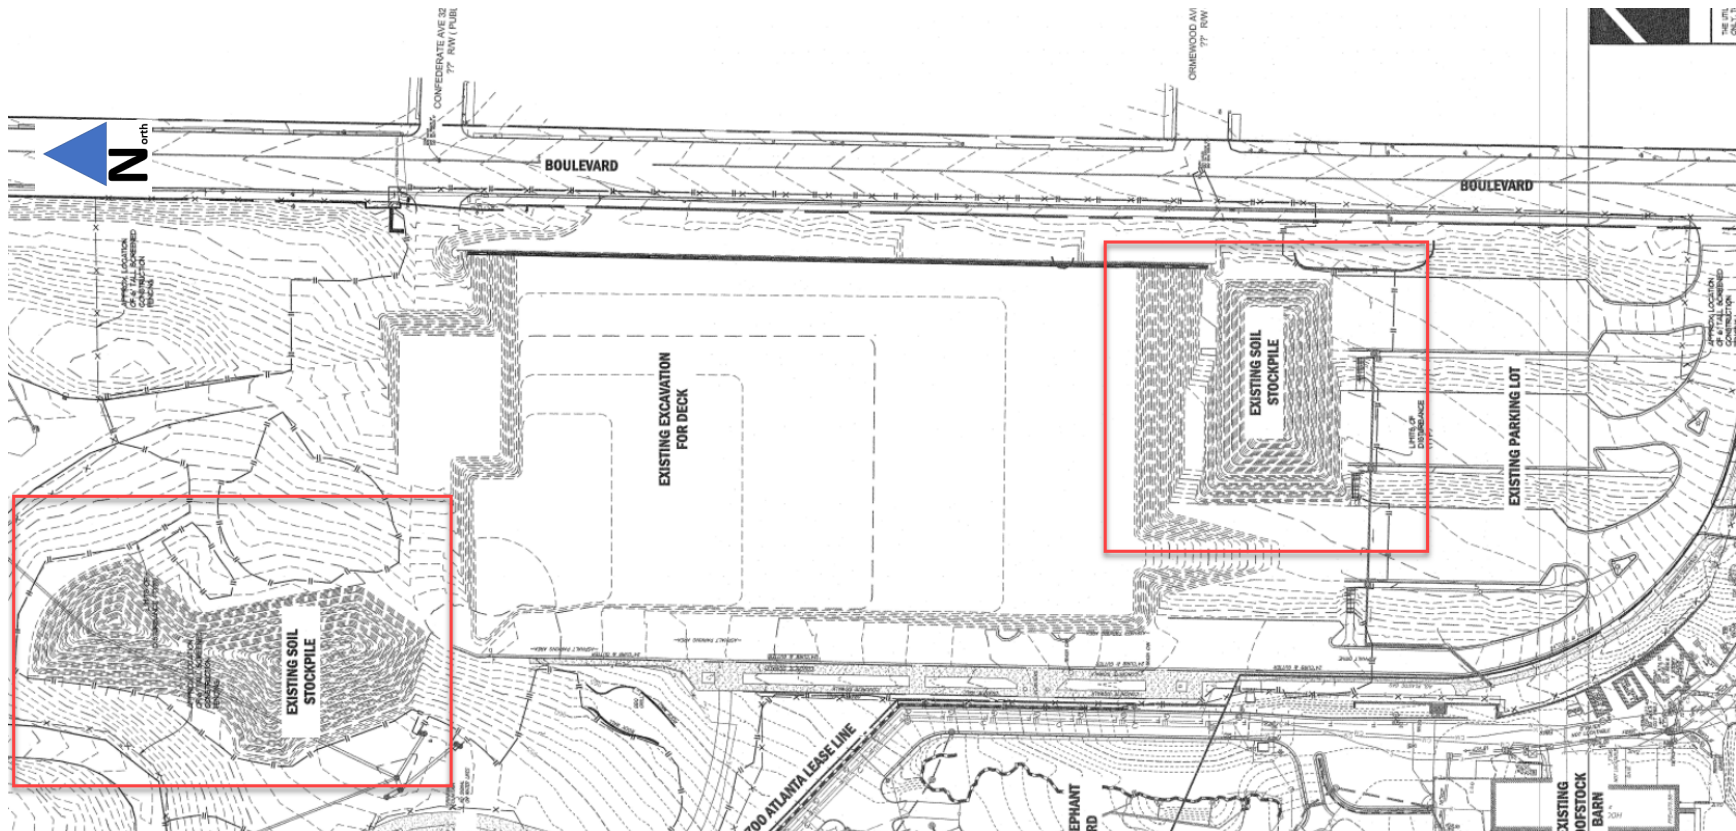
Image from page C020 of the 7/31/2017 plans showing the two soil stockpiles from excavation for the deck.

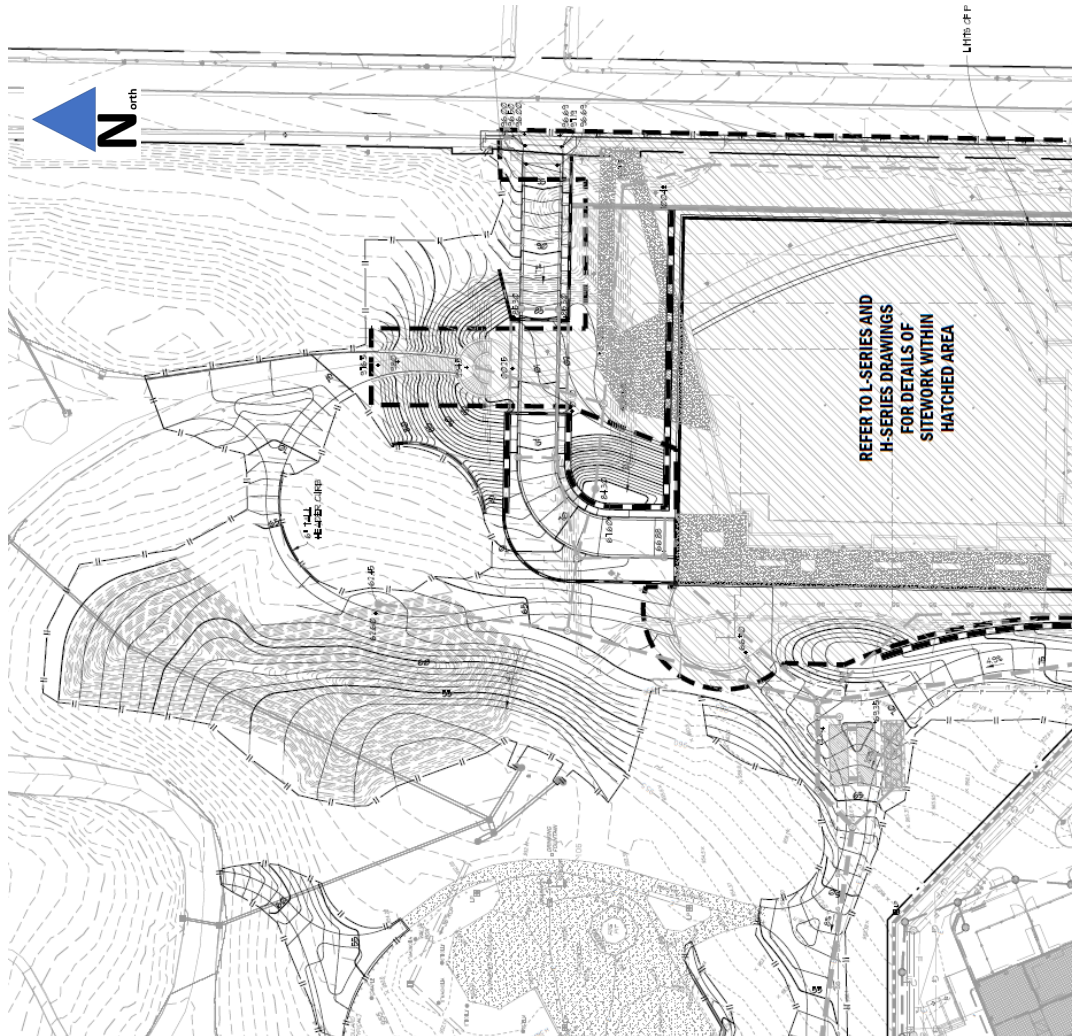
Image from page C300 of the 7/21/2017 plans showing the two existing stockpiles remaining and the regrading of the bowl (non-dashed lines are where regrading is occurring).

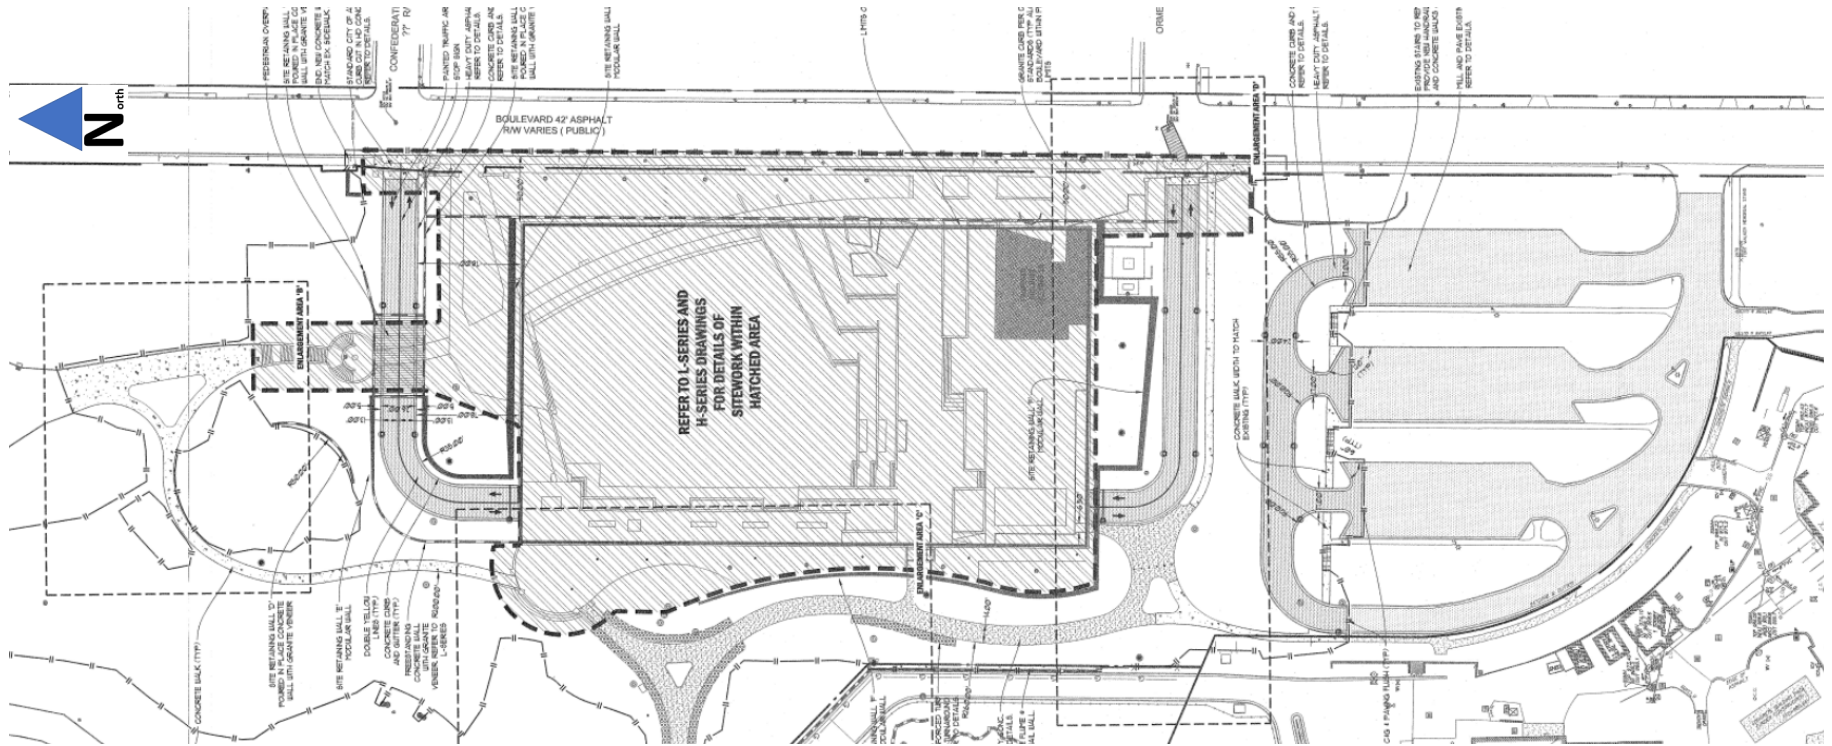
Image from page C200 of the 7/31/2017 plans showing the remaining asphalt lot and the asphalt road being added to connect the lot.
